Long Island Permeable Pavement Providing Long-Term Surface Infiltration Performance Data

An 8,800 SF permeable interlocking concrete pavement (PICP) was installed in 2010 at a commercial facility at Century Building Materials, a construction supply yard in Lindenhurst, Long Island, New York. A PICP system was installed to manage stormwater in lieu of twenty dry wells. The innovative green project provided a real financial incentive along with an aesthetic heavy duty pavement to the property owner.

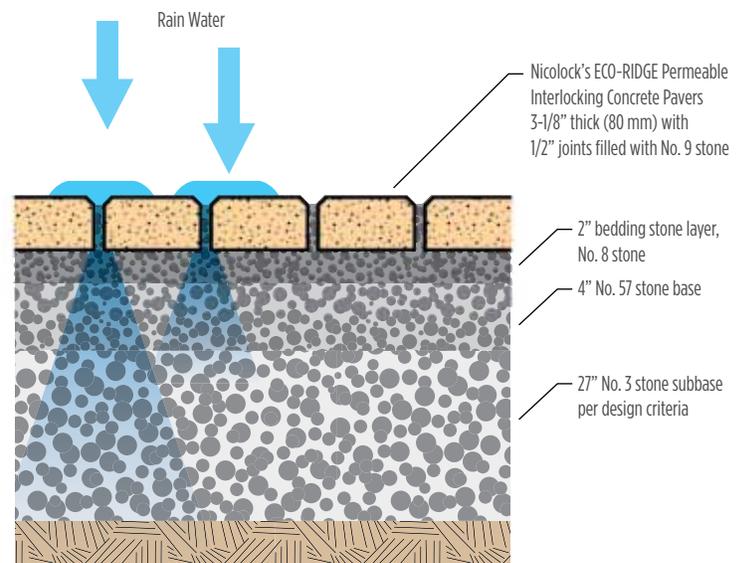
PICP Cross Section

The total drainage design volume calculation was based on a 1.5" rainfall local regulatory requirement for 100,000 SF of the property. A minimum surface infiltration design rate of 10 in/hr was established. The resulting PICP cross-section installed was a 36-inch thick flexible pavement.

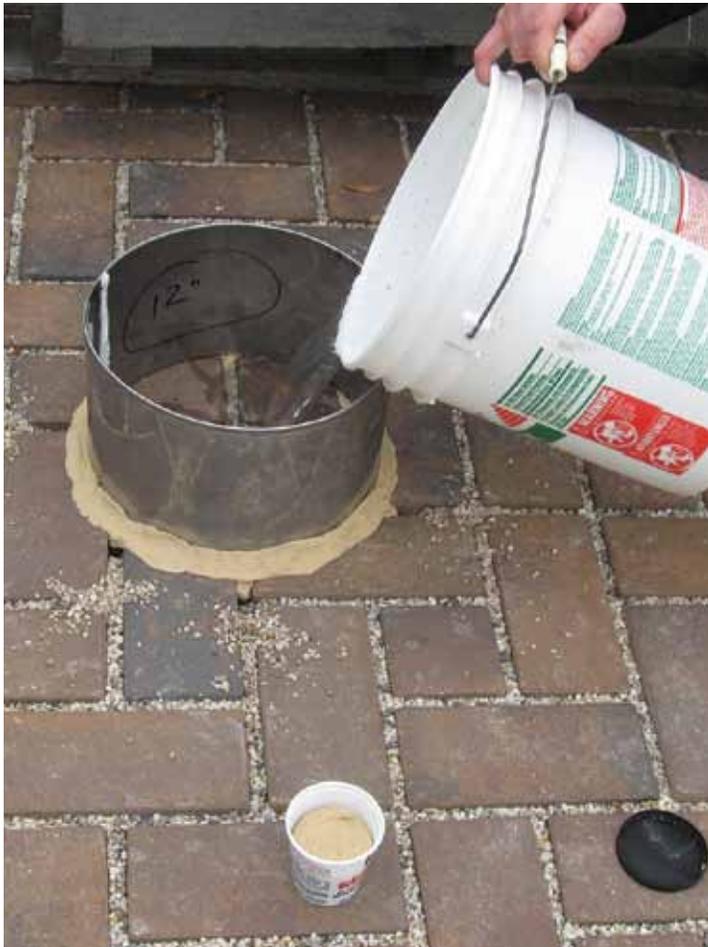
Surface infiltration testing was carried out in accordance adapted ASTM C1701, Standard Test Method for Infiltration Rate of In Place Pervious Concrete. Test methodology included pre-wetting, and two iterations at three locations. The field test utilized a constant head single ring Infiltrometer with plumber's putty used to seal the ring to the pavement.

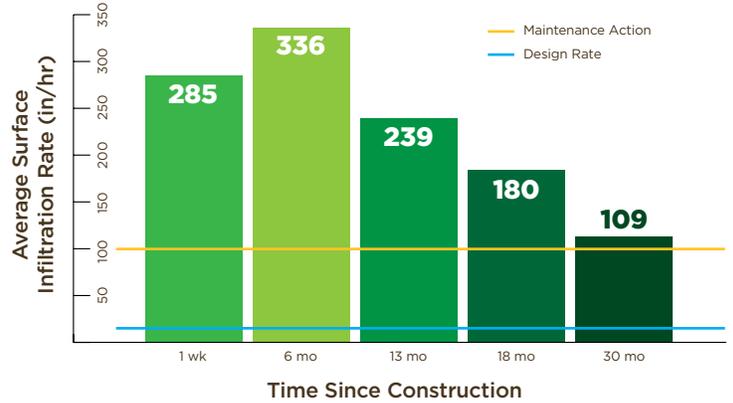
Surface Infiltration Over Time

The PICP system is performing as designed and is not generating any run-off even during large rainfall events. Five rounds of post-construction surface infiltration tests using ASTM C1701 have been completed to date. No joint maintenance has been done at the site so that the effect of clogging could be measured over a period of time.

Since installation, the project site has received record regional rainfalls. To date, standing water on the PICP installation has not been observed, nor has any run-off occurred, even during Hurricane Irene (4.4 inches), or Super Storm Sandy. Since no maintenance has occurred at this commercially active facility, a decrease in surface infiltration rates over time was expected. Surface infiltration rates remain well above the 10 in/hr design. A vacuum sweep program of the PICP surface will be implemented when the infiltration rate falls below the 100 in/hr maintenance action level. Data will be collected following the vacuum program to evaluate the effectiveness of vacuuming the pavement surface.
